METAL / NONMETAL

Serious Injury Accident

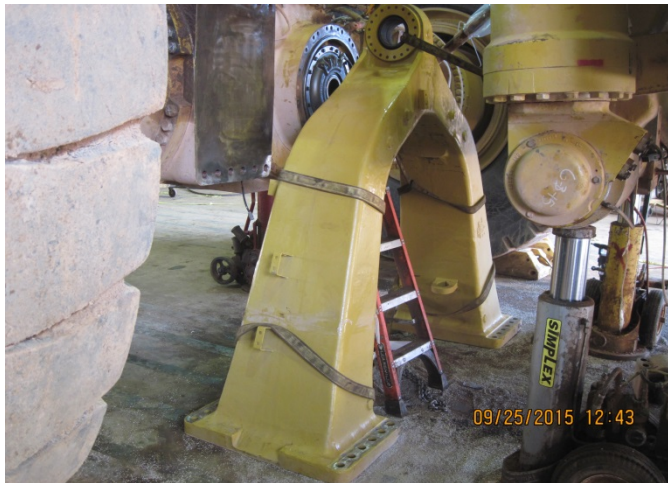
Surface Copper Mine – A miner was preparing to reposition an axle support in a Caterpillar 793H Haul Truck that was leaning against a torque tube. The miner was between the axle support and the differential while attempting to attach a clevis pin. The axle support shifted pinning the miner between the differential and the axle support. The miner suffered several broken ribs and bruised lungs.

- Establish and discuss safe work procedures.
- Examine work areas and identify and control all hazards before starting any work.
- Ensure material is properly blocked to prevent unexpected movement. Assure energy cannot be released while the task is performed.
- Do not place yourself in a position that will expose you to hazards while performing a task.
- Monitor personnel routinely to determine that safe work procedures are followed.
